# Contractor Inspection Report

241 nose dr, Florissant, MO, 63031

# AIRA INSPECTION SUMMARY

AI-Powered Roof Analysis

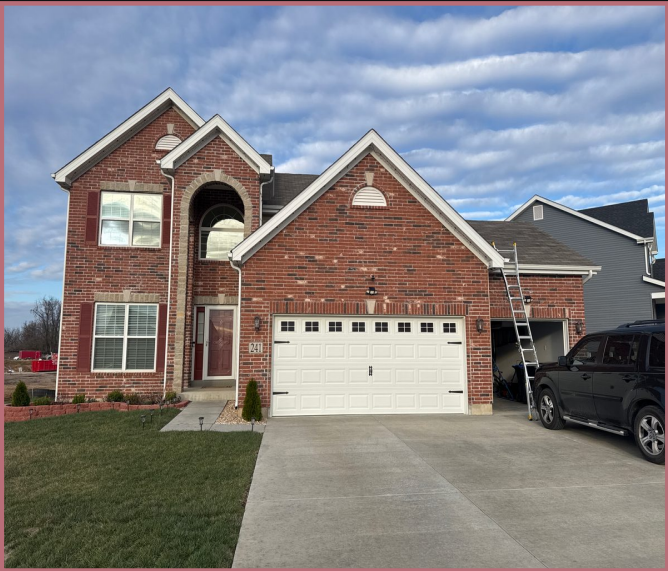
Full property risk photo

Comprehensive exterior view of the property, showcasing overall condition and potential areas for inspection.

Condition: Good

The property appears well-maintained with no visible damage to the roof or exterior walls. The landscaping is tidy, and the driveway is in good condition. However, there is a ladder present, suggesting potential ongoing inspection or maintenance activities.

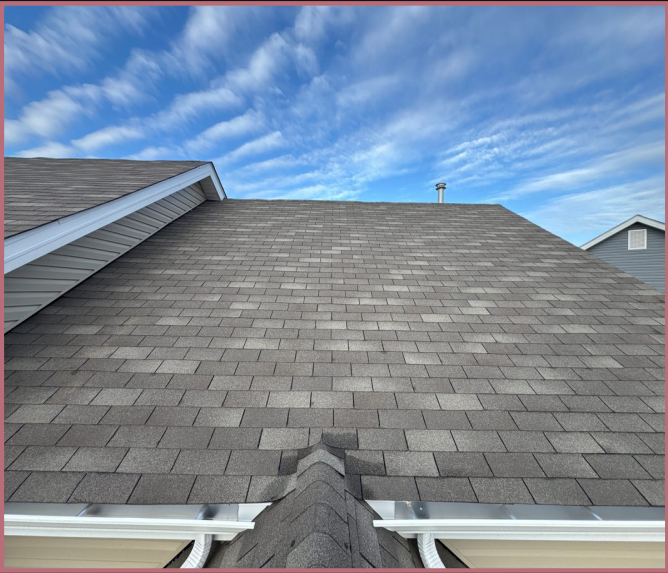
House - Front Slope - Overview

Overview of Front Roof Slope - No Visible Damages

The roof appears to be in good condition with no visible signs of damage or wear. The shingles are uniformly installed with no apparent lifting or missing materials. The roof slope is clear of debris and shows no signs of moisture accumulation or discoloration that would indicate leaks or wear.

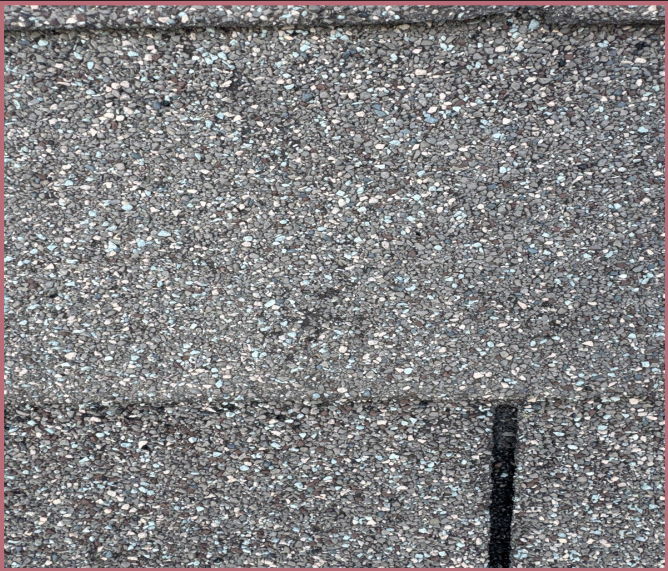
House - Front Slope - Roof Condition

Inspection of roof showing signs of granule loss due to wear and tear.

The image shows a close-up view of shingles on the front slope of the roof. There is notable granule loss occurring across the shingles, which is typical for an aging asphalt shingle roof. The exposed asphalt may lead to accelerated deterioration if not addressed, but no punctures or major damages are visible.

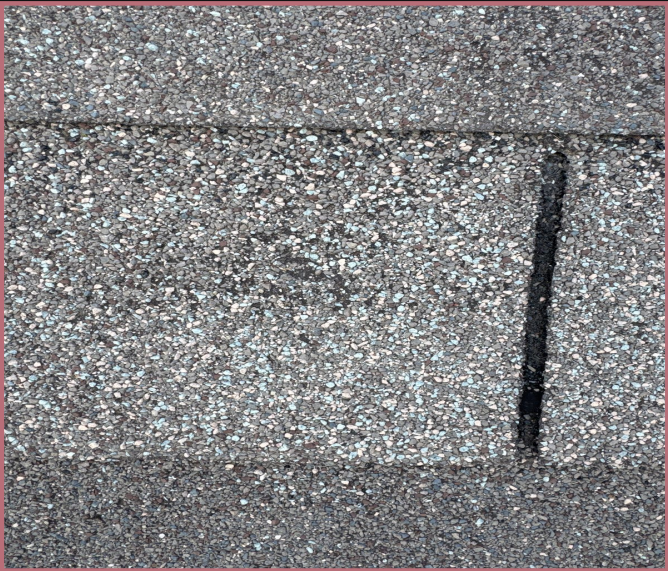
House - Front Slope - Roof Condition

Inspection of roof showing minor wear and tear with visible cracking on shingles.

The roof appears to be composed of asphalt shingles with a moderate amount of granule loss. The prominent crack suggests that the shingles may be reaching the end of their useful life. There are no visible signs of storm-related damage such as extensive lifting or missing shingles.

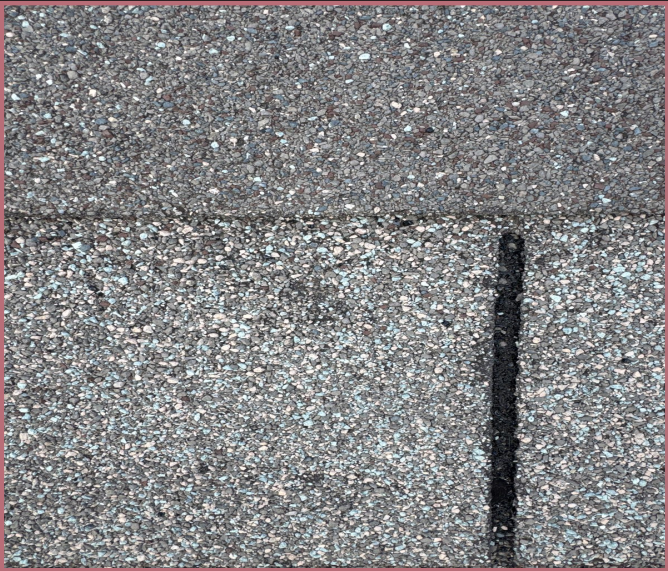
House - Front Slope - Roof Condition

Inspection of the front slope roof reveals minor wear and granule loss in asphalt shingles.

The asphalt shingles show signs of granule loss, particularly in certain areas. While this condition can be attributed to age or environmental factors, the integrity of the roof appears largely intact. No immediate signs of significant damage or leaks are visible at this point.

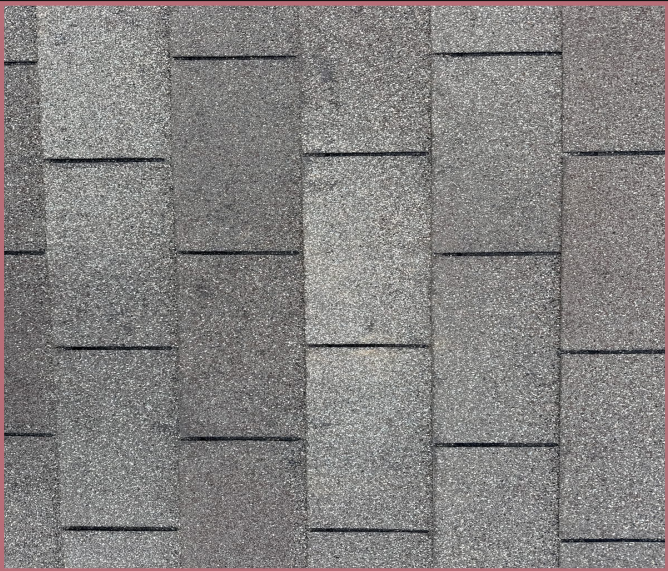
House - Front Slope - Roof Condition

Roof condition assessment revealing no immediate visible damages on front slope.

The image shows the front slope of an asphalt shingle roof. The shingles appear to be in generally good condition, with no visible tears, missing shingles, or curling noted. The granule loss is not prominent, which indicates adequate wear across the shingles. Overall, the integrity of the roof appears satisfactory upon visual inspection.

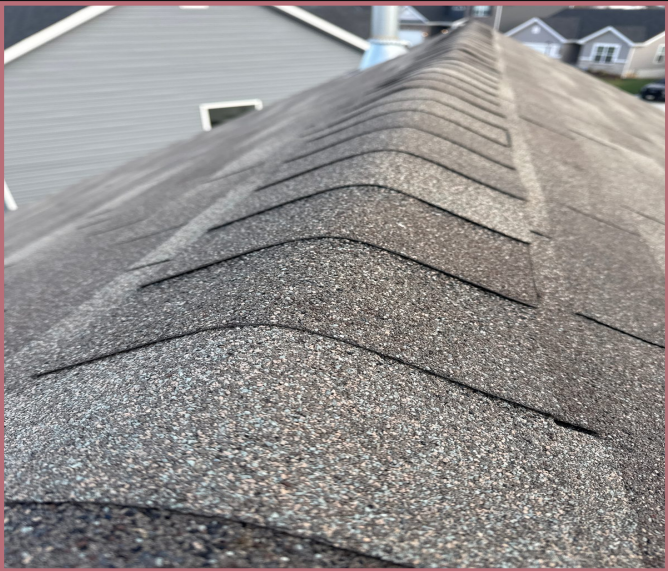
House - Front Slope - Hip/ridge

Overview of the front slope of the hip roof, showing asphalt shingles in good condition with no visible damages.

Condition: Good

The roof appears to be in overall good condition with no visible signs of damage from storms or other causes. The asphalt shingles are intact, properly aligned, and show no excessive wear or granule loss.

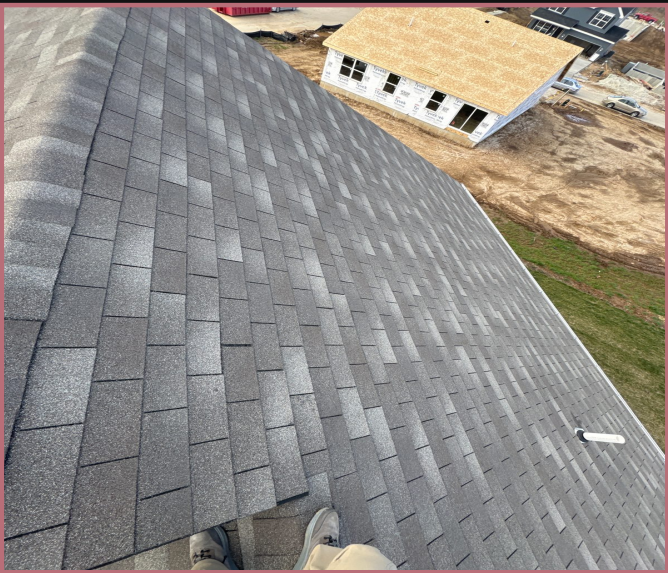
House - Back Slope - Overview

Overview of the rear slope of the roof exhibiting a uniform appearance with no visible signs of damage or wear.

The photograph captures a clear view of the roof's back slope, which appears to be in good condition. The shingles are aligned correctly, and there is no visible discoloration, curling, or damage. Additionally, the surrounding area shows signs of new construction, suggesting the roof might be relatively new.

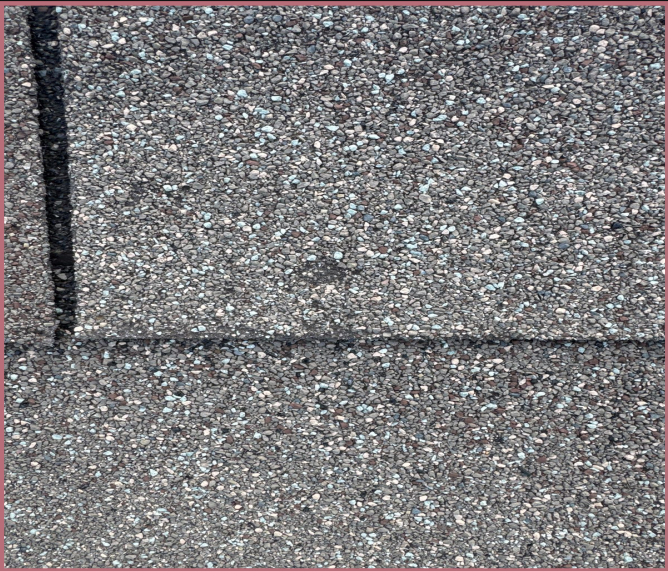
House - Back Slope - Roof Condition

Detailed examination of wear and moisture indicators on the upper back slope of the roof.

The roof shows signs of aging with visible granule loss and dark patches that may indicate moisture issues. Both are commonly associated with standard wear and tear rather than recent storm damage. The lack of shingle displacement or significant cracking further suggests that the observed conditions are likely due to long-term exposure rather than acute weather events.

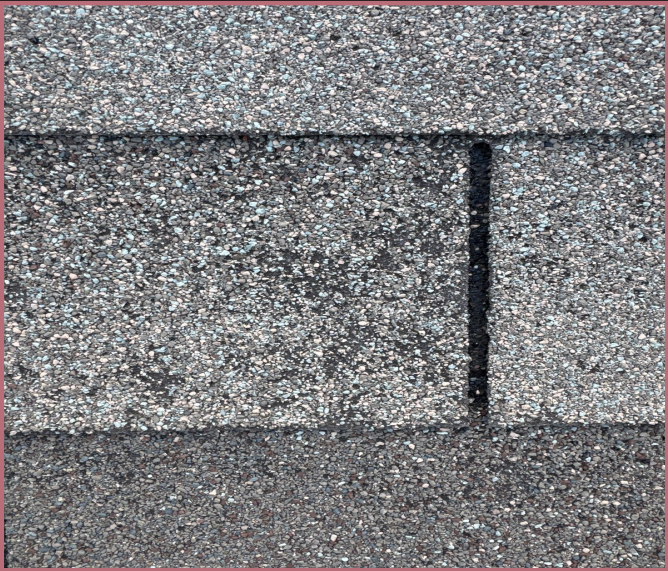
House - Back Slope - Roof Condition

Inspection of back slope roof condition reveals signs of wear and tear that could affect long-term performance.

The shingles exhibit notable granule loss, primarily affecting the uppermost layers where water drainage may be at risk. The alignment of shingles shows some areas where wear could lead to moisture ingress. Further inspection is recommended to evaluate underlying materials for potential damage.

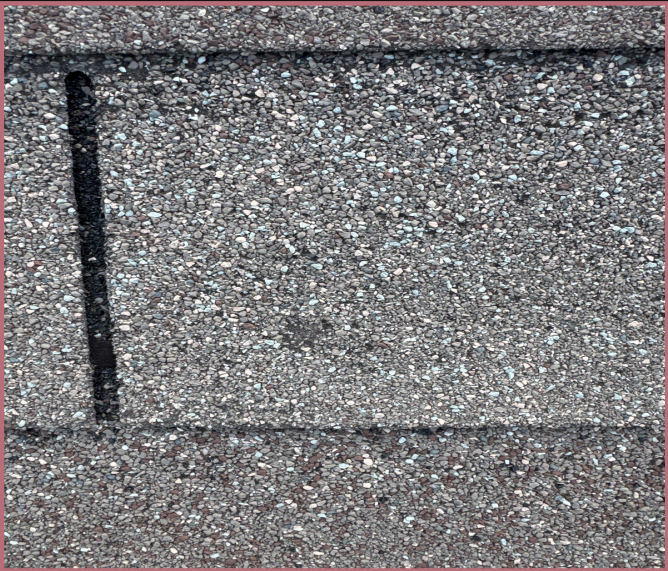
House - Back Slope - Roof Condition

Inspection of the back slope roof shows no identifiable damage or issues requiring immediate attention.

The inspected area of the roof appears to be in good condition with no visible signs of damage such as granule loss, cracking, or deterioration. The surface is intact, and there are no areas showing moisture intrusion or wear and tear. A closer examination does not reveal any structural concerns or safety hazards.

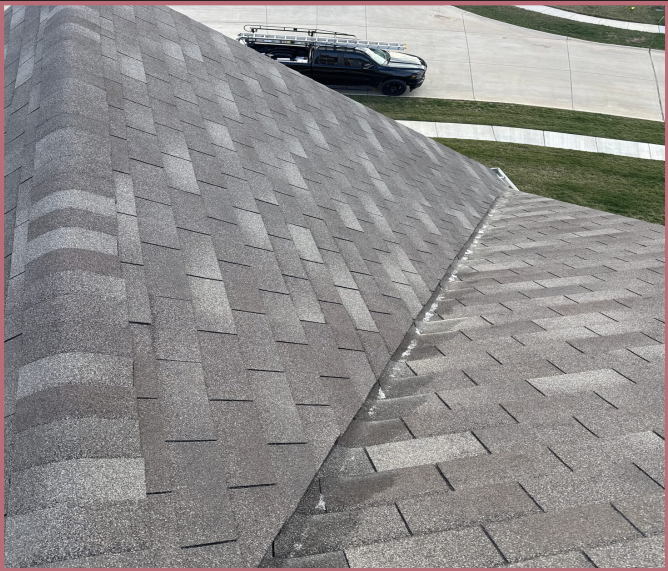
House - Left Slope - Overview

Overview of the left slope of the roof showing wear and potential areas of concern for moisture intrusion.

The left slope exhibits some wear in the shingles, particularly along the ridgeline where fading is evident. The area near the valley junction displays possible water stains, indicating prior moisture presence. No significant deformities or missing shingles were observed in the immediate view, but aging materials may contribute to future issues.

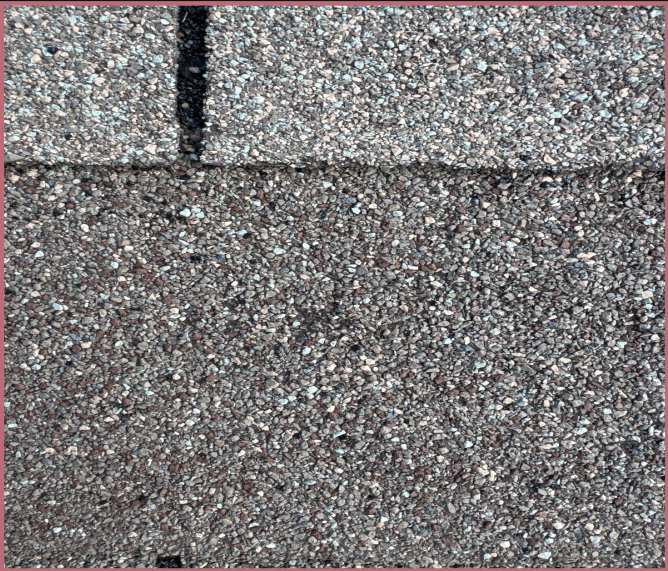
House - Left Slope - Roof Condition

Inspection of the left slope roof condition shows signs of wear and potential moisture retention, requiring attention.

The roof exhibits noticeable granule loss, typical of aging shingles. The presence of black streaking suggests the possibility of moisture retention or algae growth, which can compromise the integrity of the material.

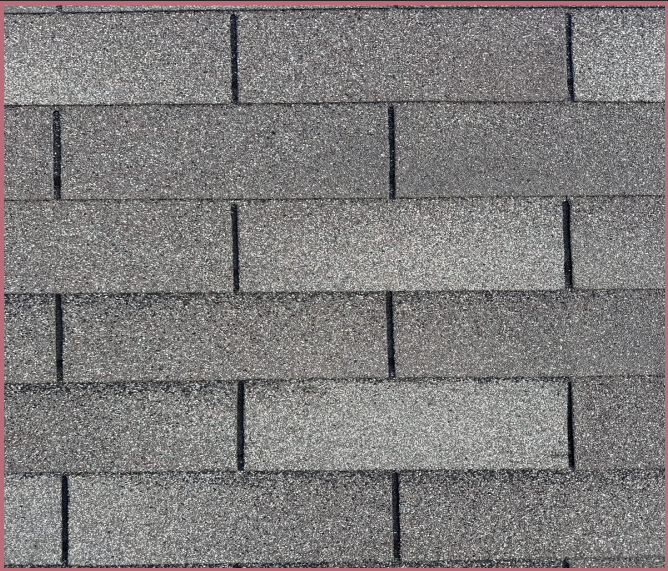
House - Left Slope - Roof Condition

Inspection of the left slope roof condition showing asphalt shingles in standard layout with no visible signs of damage.

The photo presents a clear view of the asphalt shingles on the left slope of the roof. The shingles appear to be installed in an even, standard pattern with no visible curling, lifting, or missing pieces. The granule loss is minimal and evenly distributed across the surface, indicating adequate maintenance; however, the absence of detailed close-ups limits a full assessment.

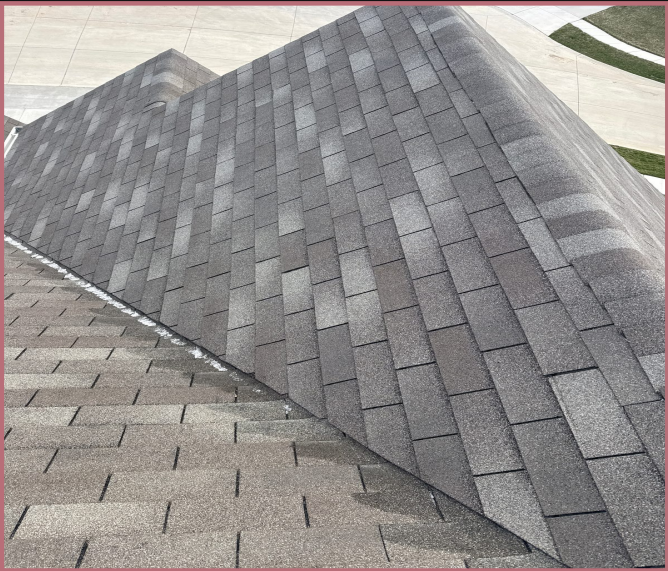
House - Right Slope - Overview

Overview of the roof's right slope showing consistent shingle alignment and no apparent damage.

The roof slopes appear to be in fair condition. The shingles are aligned properly, and no dislocations, cracks, or missing shingles were observed. Reflective patterns may indicate slight wear but are not significant. No immediate concerns noted that would indicate need for urgent repairs or storm-related damage.

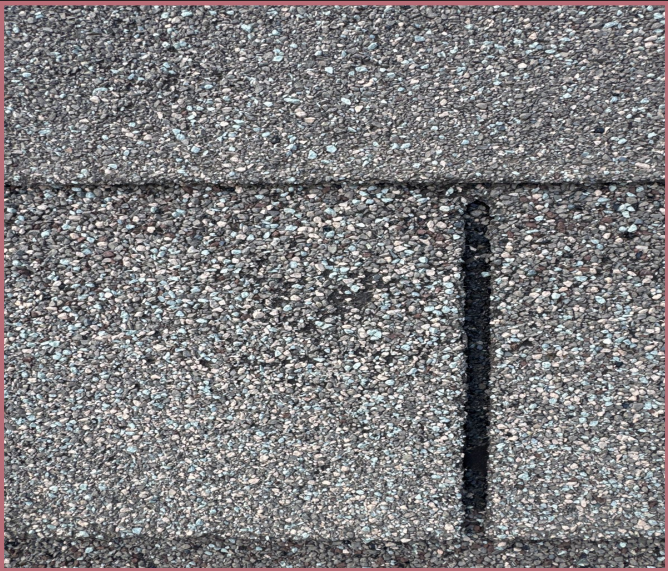
House - Right Slope - Roof Condition

Inspection reveals significant wear and tear on the right slope roof, with visible cracks and granule loss.

The roof shows signs of aging with noticeable cracks and granule loss that can lead to further deterioration if not addressed. The photo depicts areas where moisture may enter, compromising the underlying structure. Regular maintenance and inspections are crucial to prolong roof lifespan.

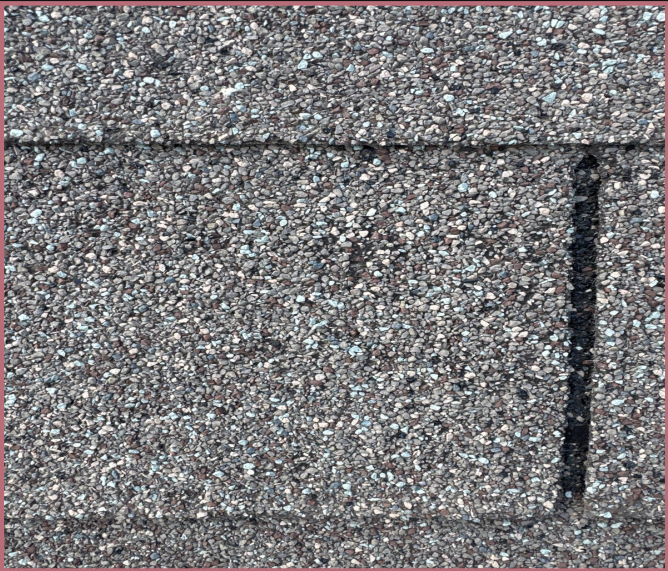
House - Right Slope - Roof Condition

Detailed examination of the right slope roofing indicates moderate wear and tear, with visible granule loss and potential moisture exposure areas.

The roof shows signs of aging, with noticeable granule loss and surface cracking which can compromise the integrity of the shingles. These conditions, while not immediately catastrophic, suggest the need for proactive maintenance to avoid future water damage.

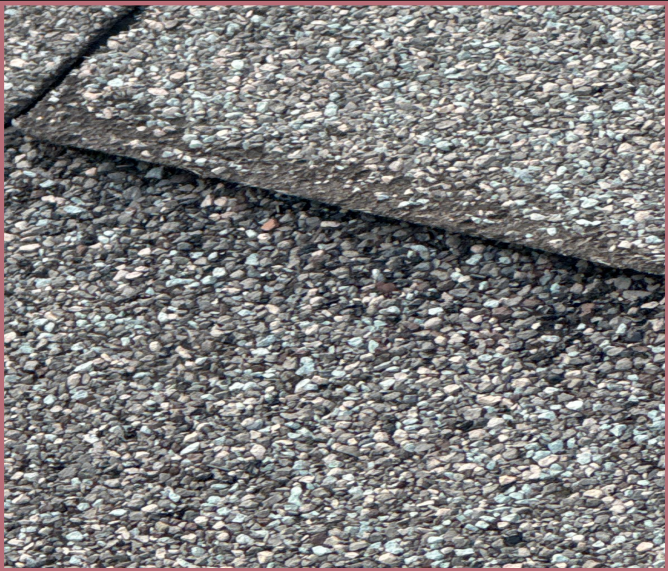
House - Right Slope - Roof Condition

Inspection of the right slope of the roof shows no visible damages or issues requiring immediate attention.

Condition: Good

The condition of the roofing material appears to be intact with no visible cracks, missing shingles, or signs of wear and tear. The granules are evenly distributed, indicating proper installation and maintenance.
