#### AT A GLANCE

## 1 PLOT & VISIT DETAILS

| VILLAGE / LOCATION | Rohtak district, Haryana — exact village withheld in this sample copy |
| APPROX. AREA | 250 sq. yd. |

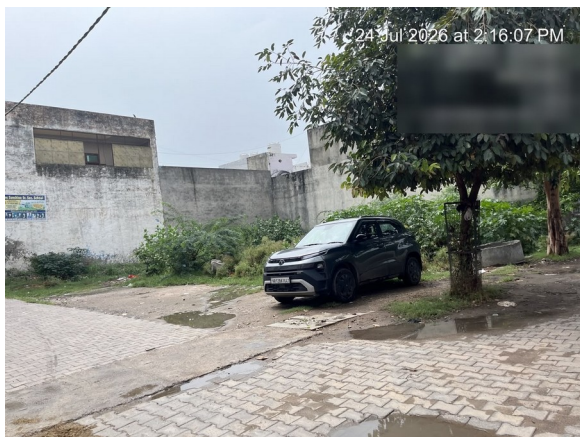
**Photo 1.** Full plot frontage viewed from the access road; adjoining school building on the left. 14:16.

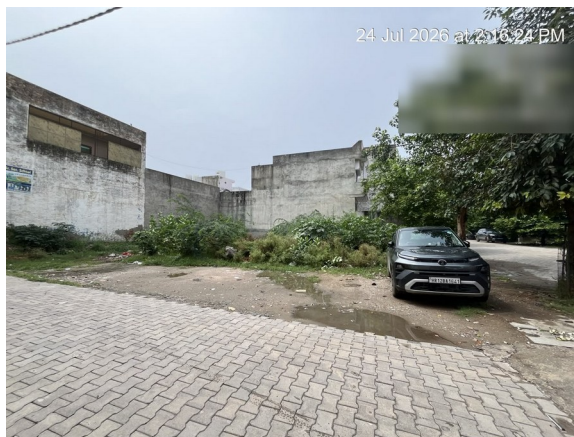
**Photo 2.** Plot and paved approach from the opposite corner, facing the rear boundary. 14:16.

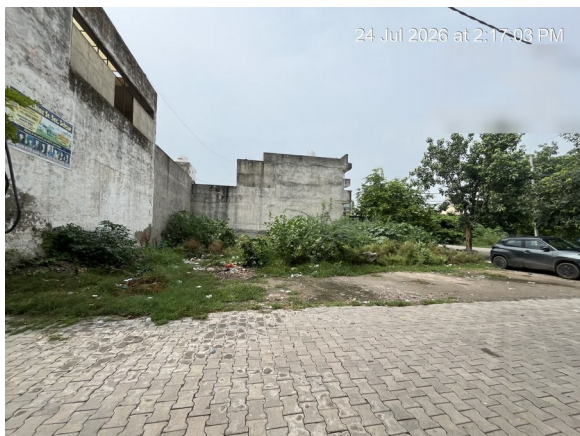
| BOUNDARY CONDITION | No independent boundary wall or fencing around the plot. Walls of adjoining structures run along two sides. |

**Photo 3.** School-side edge of the plot. No independent boundary wall on this side. 14:17.

| RECOMMENDED ACTION | Weed and vegetation removal, garbage and debris disposal, and ground levelling. Temporary fencing or corner pillars are advised to make the boundary visible and discourage informal use. |

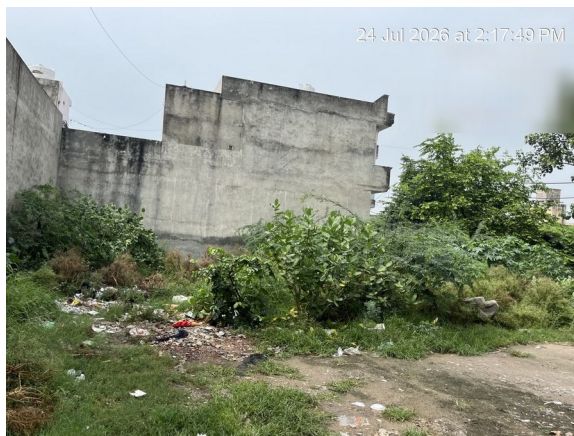
**Photo 4.** Rear edge. Walls of adjoining structures act as the de-facto boundary. 14:17.

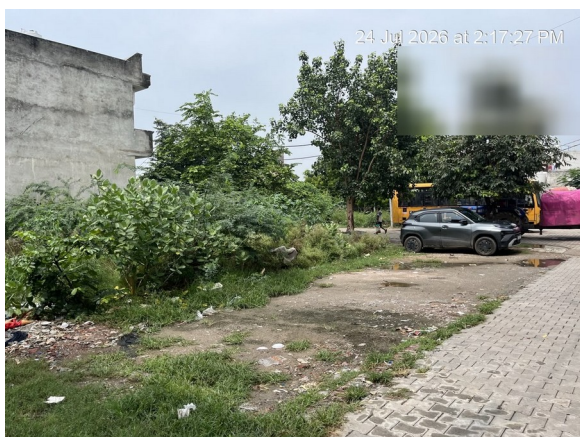
| OVERGROWTH | Heavy grass, bushes and wild vegetation across a large portion of the site. |

**Photo 5.** Looking from the plot toward the road; overgrowth along the left margin. 14:17.

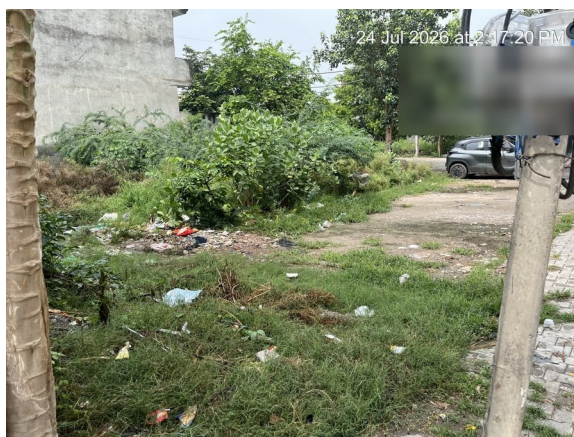
| DUMPING OR WASTE | Construction debris, plastic waste and scattered garbage in several areas, concentrated at the rear corner. |

**Photo 6.** Close-up: grass and scattered plastic waste over the open hard ground. 14:17.

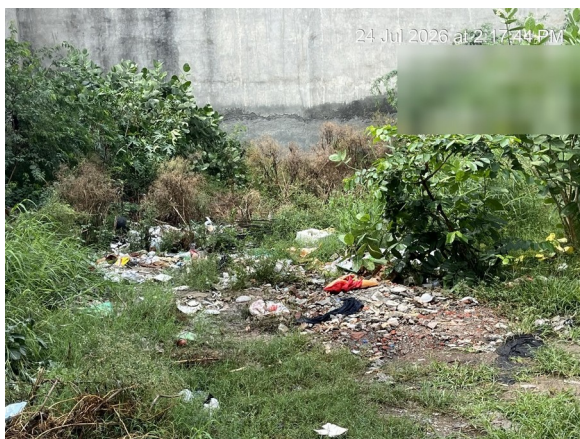
**Photo 7.** Close-up: construction debris and garbage collected at the rear corner. 14:17.

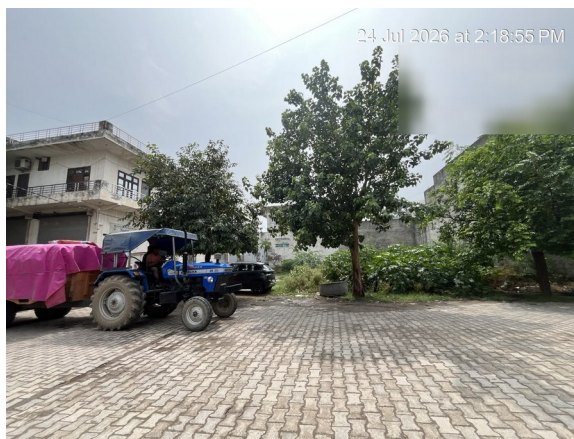
| ACCESS PATH | Clear. Approach is a paved interlocking road; car and tractor movement was observed during the visit. |

**Photo 8.** Access road at the plot frontage — paved and wide enough for tractor and car movement. 14:18.
