SunOptics Impact Testing  
Skylight Testing  
Haag Research & Testing Co.  
1410 Lakeside Parkway, Suite 100  
Flower Mound, TX 75028  
Client File: N/A  
Haag File: 51240066TX -196

In accordance with your request, we impact tested plastic skylights to evaluate the effects of large, frozen solid hailstones.

The tested skylights were a double-dome design. The outer dome was 0.118-inch, clear, smooth polycarbonate. The inner dome was 0.125-inch, white, prismatic polycarbonate. Domes were separated by a 1/2-inch air gap. The skylight measured nominally 61-1/2 inches wide by 73-1/2

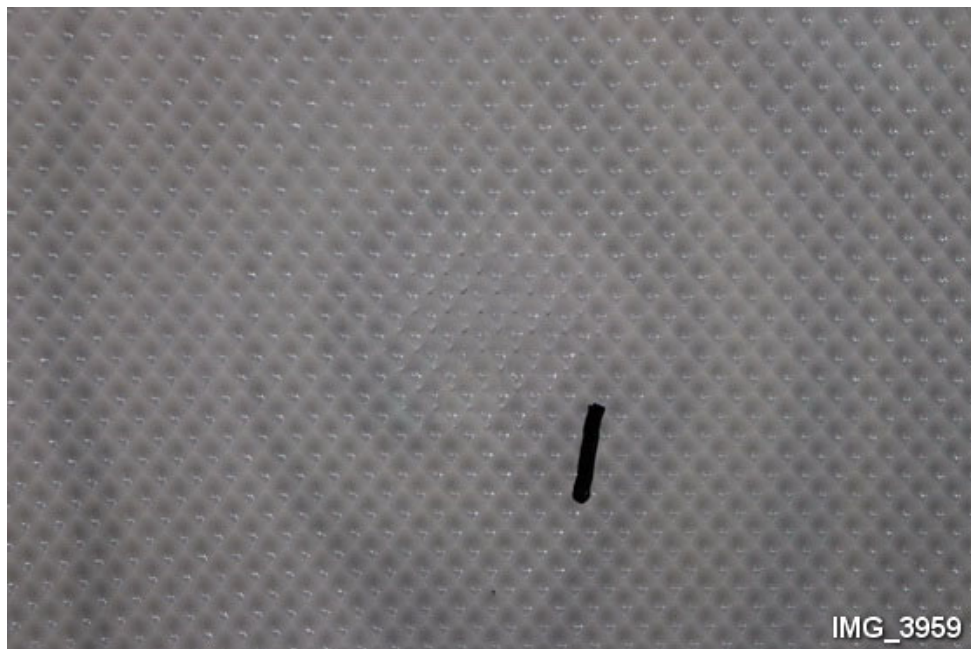
| IMPACT No. | Location | SIZE [Inch] | MASS [Pound] | SPEED [Ft/Sec] | KE [Ft-Lbf] | FINDINGS |
|---|---|---|---|---|---|---|
| 1 | End | 4 | 1.0943 | 159.4 | 432.1 | dent |

D4. Overview of Impact 1 with 4 inch ice ball. (Note impact caused dent.)

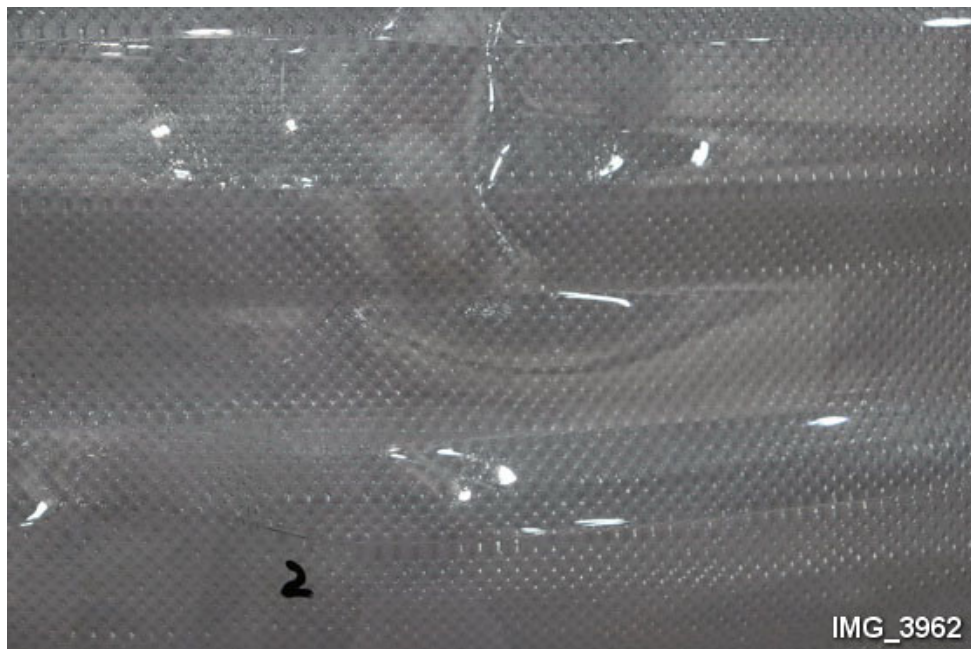
| IMPACT No. | Location | SIZE [Inch] | MASS [Pound] | SPEED [Ft/Sec] | KE [Ft-Lbf] | FINDINGS |
|---|---|---|---|---|---|---|
| 2 | Rib | 4 | 1.1327 | 219.4 | 847.4 | dent; buckled rib |

1. The skylights were subjected to impacts by simulated hailstones (frozen solid ice balls) propelled perpendicular to six target locations (Figure 1) at velocities consistent with free-fall speeds of 4-inch-diameter hail.
2. Skylights were dented at ice ball impacts.
3. Impact 2 on a rib element buckled the rib.
4. Individual ice ball impacts did not crack or puncture the skylight domes.

D6. Overview of Impact 2 with 4 inch ice ball. (Note impact caused dent and buckle.)

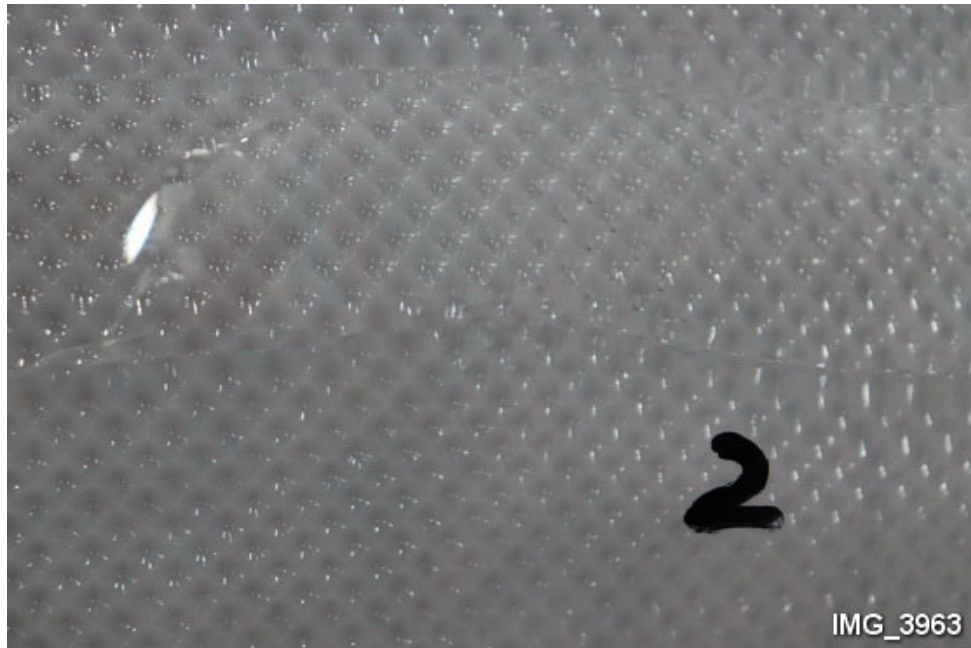
D7. Close-up of Impact 2.

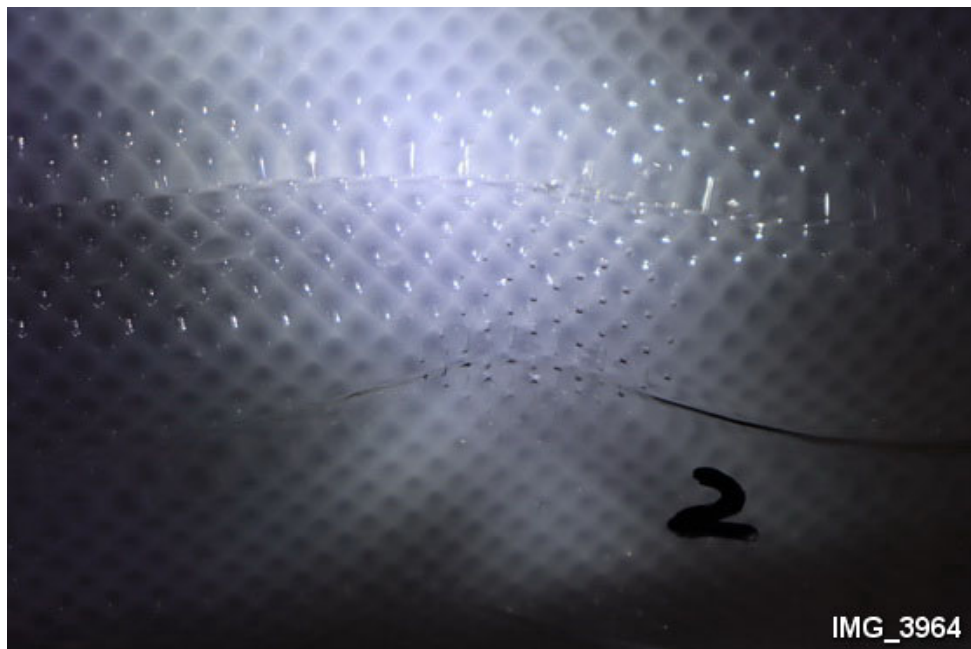
D8. Close-up of Impact 2 using low angle lighting.

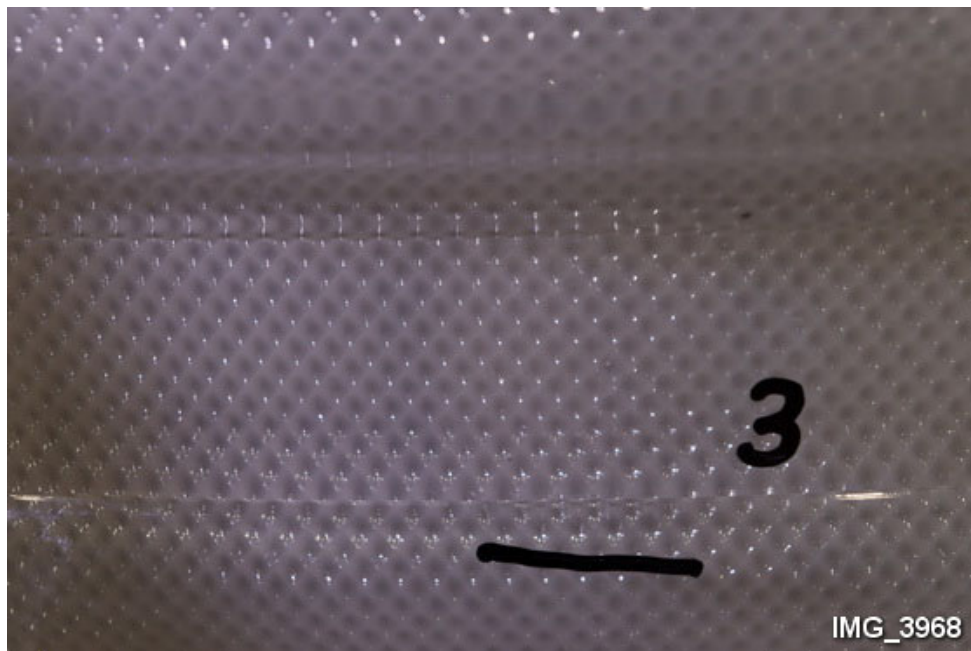
| IMPACT No. | Location | SIZE [Inch] | MASS [Pound] | SPEED [Ft/Sec] | KE [Ft-Lbf] | FINDINGS |
|---|---|---|---|---|---|---|
| 3 | Valley | 4 | 1.0927 | 157.8 | 422.9 | dent |

D10. Overview of Impact 3 with 4 inch ice ball. (Note impact caused dent.)

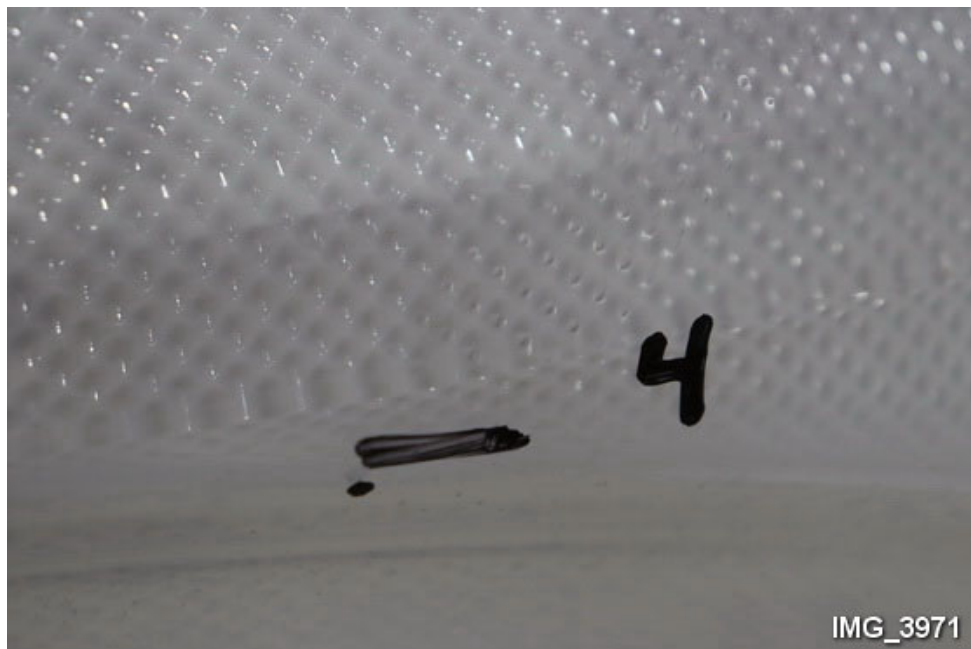
| IMPACT No. | Location | SIZE [Inch] | MASS [Pound] | SPEED [Ft/Sec] | KE [Ft-Lbf] | FINDINGS |
|---|---|---|---|---|---|---|
| 4 | Edge/Rib | 4 | 1.0748 | 156.5 | 409.1 | dent |

D12. Overview of Impact 4 with 4 inch ice ball. (Note impact caused dent.)

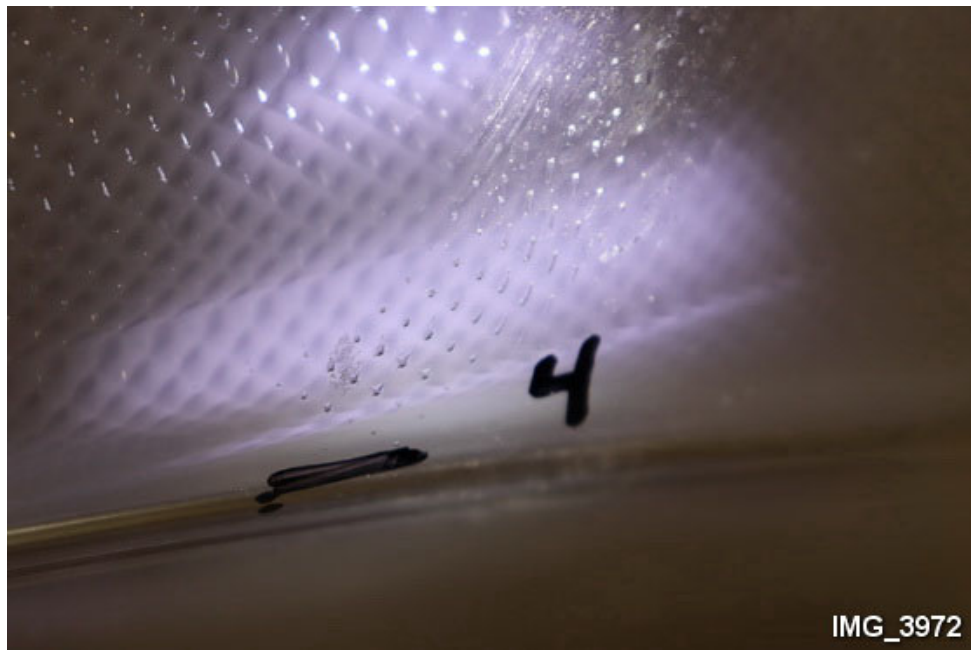
D13. Close-up of Impact 4 using low angle lighting.

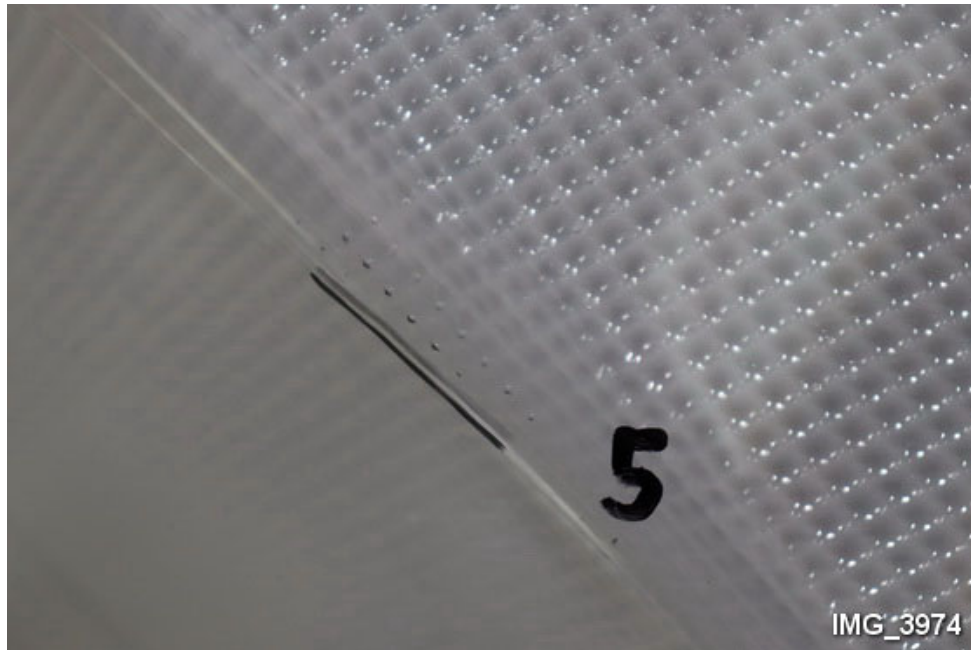
| IMPACT No. | Location | SIZE [Inch] | MASS [Pound] | SPEED [Ft/Sec] | KE [Ft-Lbf] | FINDINGS |
|---|---|---|---|---|---|---|
| 5 | Edge | 4 | 1.0870 | 151.4 | 387.3 | dent |

D15. Overview of Impact 5 with 4 inch ice ball. (Note impact caused dent.)

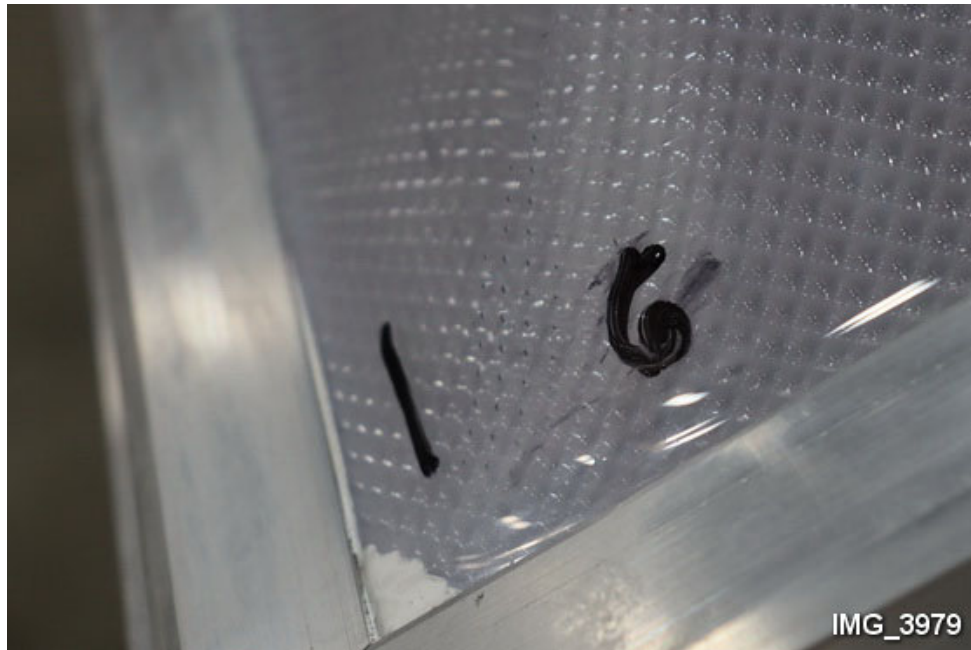
| IMPACT No. | Location | SIZE [Inch] | MASS [Pound] | SPEED [Ft/Sec] | KE [Ft-Lbf] | FINDINGS |
|---|---|---|---|---|---|---|
| 6 | Corner | 4 | 1.0956 | 156.7 | 418.1 | dent |

D17. Overview of Impact 6 with 4 inch ice ball. (Note impact caused dent.)

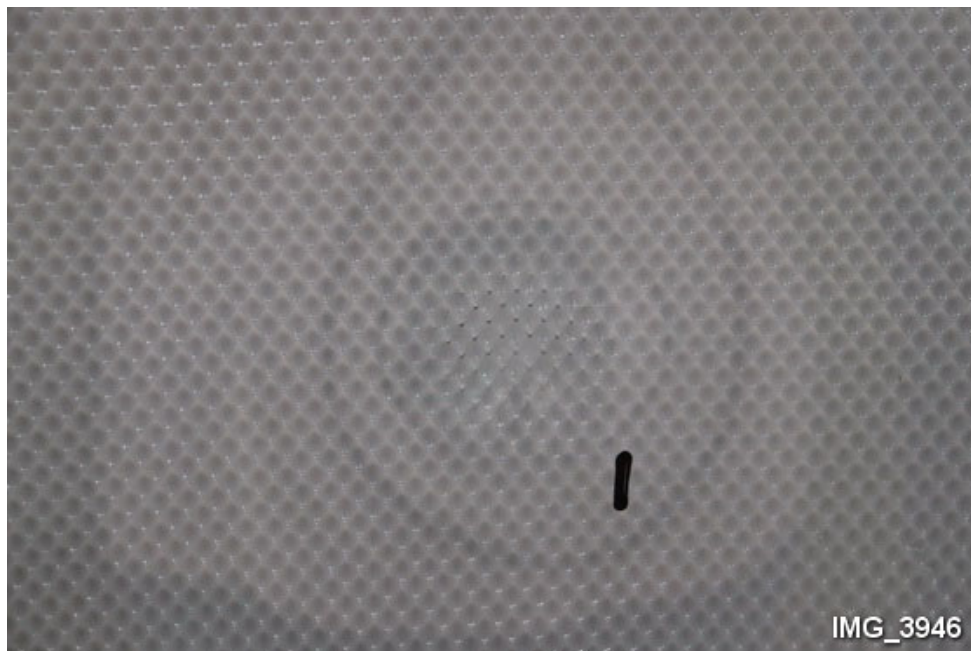
| IMPACT No. | Location | SIZE [Inch] | MASS [Pound] | SPEED [Ft/Sec] | KE [Ft-Lbf] | FINDINGS |
|---|---|---|---|---|---|---|
| 1 | End | 4 | 1.1003 | 163.3 | 456.0 | dent |

D20. Overview of Impact 1 with 4 inch ice ball. (Note impact caused dent.)

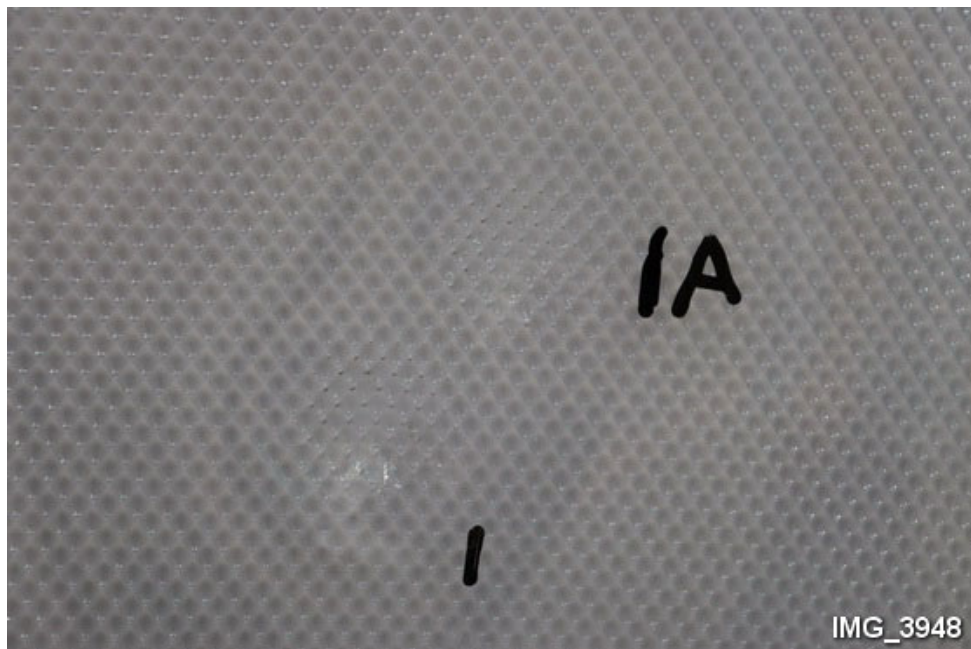
| IMPACT No. | Location | SIZE [Inch] | MASS [Pound] | SPEED [Ft/Sec] | KE [Ft-Lbf] | FINDINGS |
|---|---|---|---|---|---|---|
| 1A | End | 4 | 1.1024 | 160.2 | 439.7 | dent |

D22. Overview of Impact 1A with 4 inch ice ball located about two inches from Impact 1.
