# Marine Chain Cable

## Pocket Guide

**Lloyd's  
Register**

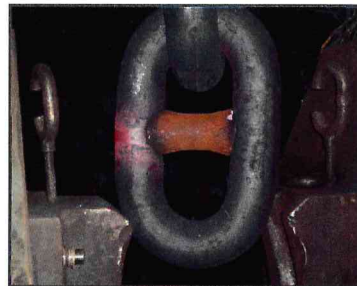
Stud link chain cable, see *Figure 1* are intended for anchoring or mooring purposes.

*Figure 1 - Stud link chain cable*

The stud has two functions; it prevents lateral deformation of the link in service, and also prevents the chain becoming entangled in the chain locker.

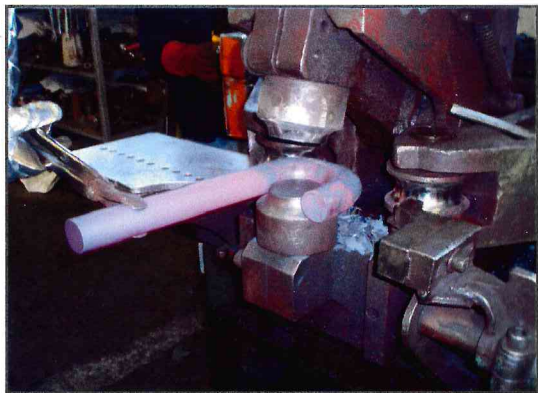
Figure 9 - Forming by bending

Once cut to length and heated, the bar is pre-bent and inserted into the last completed link. Bending is completed around formers of the appropriate diameter.

Bending must be performed within the approved temperature range. If the bending temperature is too low, insufficient ductility in the material may result in cracking.

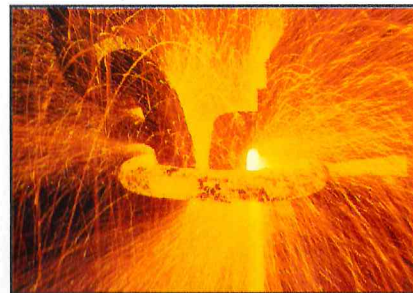
Figure 10 - Flash Butt Welding

*Figure 10*. During this process, the material in contact on the end faces are heated and softened, until the applied pressure is sufficient to force the oxide contaminated material from the interface giving a sound weld.

If properly carried out, all of the interface will be removed into the flash. If incorrectly carried out, the weld interface may contain imperfections (oxides and lack of fusion) producing a weld prone to failure.

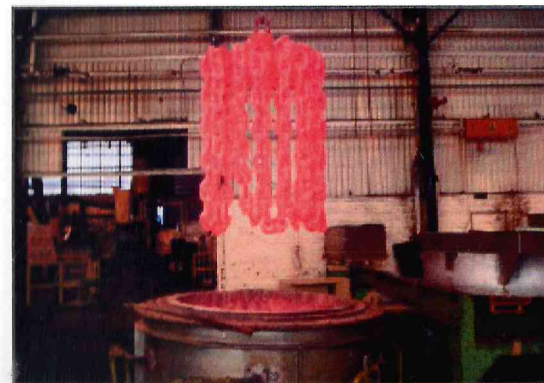
Figure 18 – An example of chain correctly fixtured for batch heat treatment

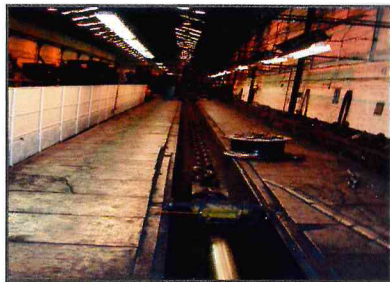
Each length of stud link chain cable is to be subjected to a proof loading test in an approved testing machine and is to withstand the load given in the Rules for the appropriate grade and size of cable. The chain must be held in a way so that no damage is done to any of the links and all links are tested.

Figure 19 - Proof testing machine

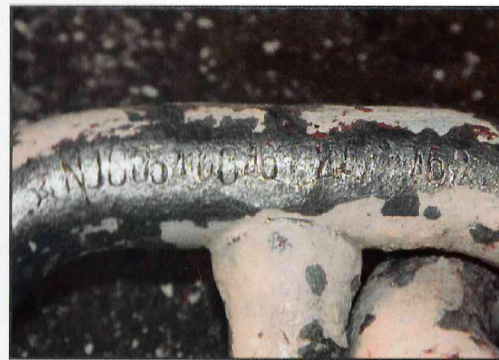
**NOTE: Markings should not cross the flash butt weld**

*Figure 23 - Example of incorrect LR stamp and incorrect stamp location.*

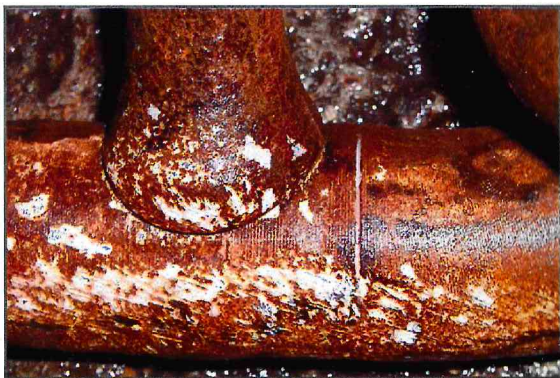
#### CD1 Machined Bar

Machining marks are evident on the chain link surface, this indicates that it has been produced from a machined bar. The use of machined bar is acceptable for the manufacture of chain cable provided the certification is current and reflects this. In this instance only one link showed evidence of machining, the rest of the chain had a surface condition indicative of manufacture from hot rolled bar. The presence of only one link in the length of chain could be indicative of problems with traceability.

**Remedial Action:** The origin and processing history of the bar should be checked. This link should be rejected, unless traceability can confirm compliance with the Rules.

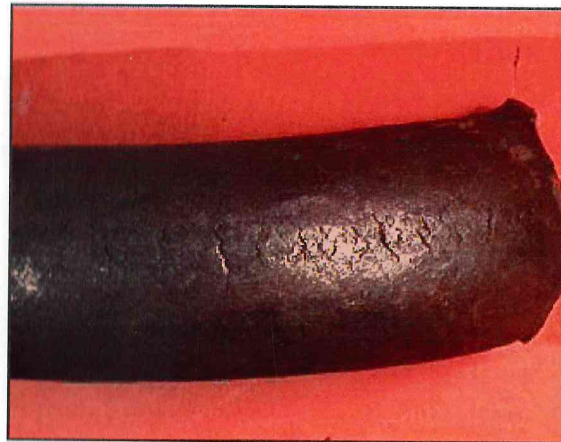
#### CD2 Cracking on Bending

This bar has insufficient ductility at the temperature at which the chain link has been formed. This could be due to a low bending temperature, or could be due to compositional issues with the steel chemistry. This will be a batch issue and therefore all chain links made at the same time should be examined for signs of cracking.

**Remedial Action:** It is unlikely that any remedial action will recover this situation the cracked links should be rejected. Any links showing such cracking may be dressed by grinding, provided dimensional tolerances are maintained. Ground chain should be checked by MPI in the presence of the LR surveyor to ensure all imperfections have been removed.

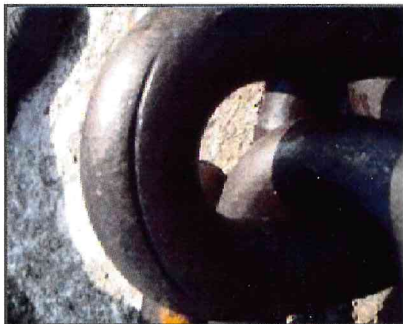
## CD3 Marking Due to Inaccurate Roll Set Up

Inaccurate set-up of the bending rolls has produced a gouge in the surface of the link.

**Action:** This link could be dressed by grinding provided dimensional tolerances are maintained.

Otherwise the link should be rejected and replaced. Weld repair is not acceptable.

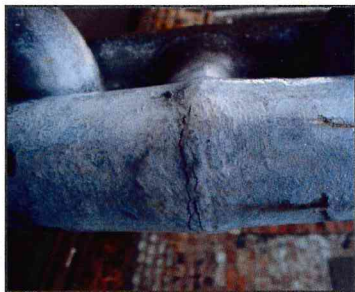
## CD 4 Lack of Fusion

Lack of fusion can be caused by inadequate heating, or inadequate pressure. If the oxide on the bar surfaces is not fully expelled into the flash, the resulting flash butt weld interface may have low ductility from contamination with oxide inclusions, making the interface

susceptible to cracking during proof load.

**Remedial Action:** Any chain links showing such cracking must be rejected. The welding conditions should be examined by the manufacturer, and the root cause of the problems identified to the satisfaction of LR. and replaced. Weld repair is not acceptable.

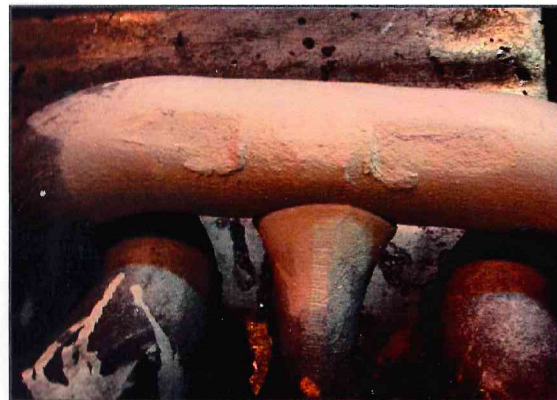
## CD5 Compression Marks

These are flat compression marks either side of the flash butt weld, caused by the clamping action of the copper grips which produce the pressure and power for the welding operation.

**Remedial Action:** If found, these should be removed by grinding, and MPI conducted to ensure there is no cracking associated with the compression marks. After grinding the link must still meet dimensional tolerances. Otherwise, the link should be rejected and replaced.

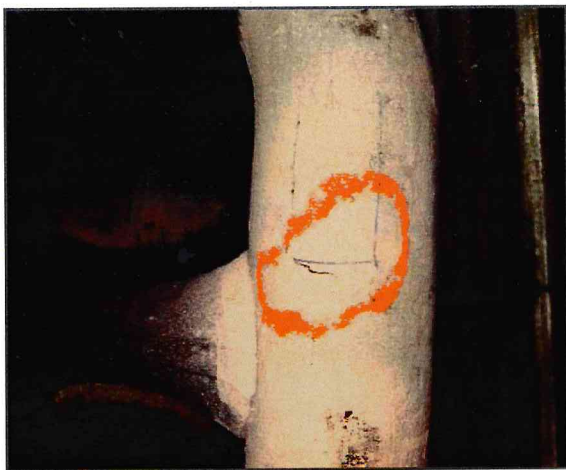
## CD6 'Copper' Cracks

They may be related to overheating / arcing in the area of contact with the copper clamps, producing a brittle microstructure.

Note that these cracks may develop some hours after welding. These are cracks which may be associated with the compression marks.

**Remedial Action:** Minor cracking can be removed by grinding. MPI should be conducted to ensure that the crack has been fully removed. The ground surface should be checked to ensure that the dimensional requirements are still met. Repair by welding is not permitted. Major cracking in a chain link is a cause for rejection.

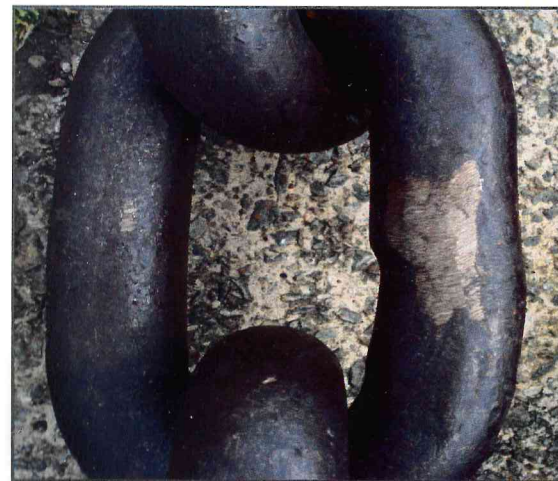
## CD7 Misaligned Flash Butt Welding

During the flash butt welding process the ends of the bar must be welded with the correct alignment to ensure the weld properties are correct and avoid forming stress raised features.

Misalignment could be due to incorrect bar length or poor fixturing during welding.

**Remedial Action:** If present such imperfections may be removed by grinding, provided the dimensions remain in Rule tolerances. Otherwise, such bars or any chain manufactured from them should be rejected and replaced.

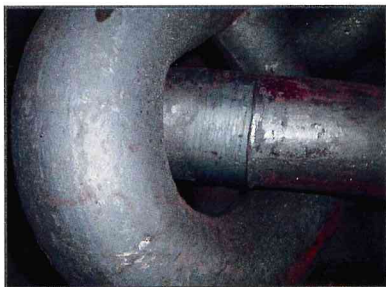
In this photograph, material has been removed from the section of the chain link during trimming, in addition to the removal of flash. This is likely to produce an under-tolerance dimension.

If outside the dimensional tolerances, the link should be rejected and replaced.

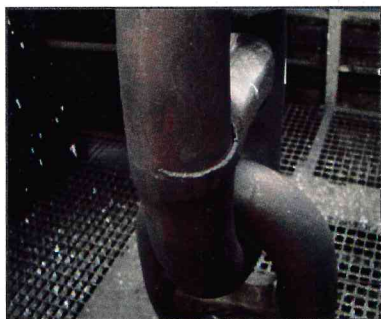
### CD9 Insufficient Flash Removal

Unacceptable excess weld flash (burr) remains on this link. The burr acts as a stress raiser in the area of the weld.

The flash can be hidden under the stud resulting in crack initiation from below the stud.

**Remedial Action:** Burr is to be removed to provide the necessary form of the link. If this cannot be done to the Surveyor's satisfaction, then the link must be replaced.

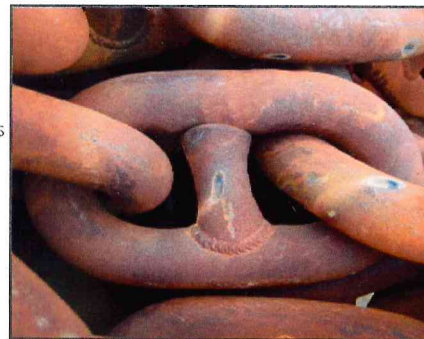
This photograph shows a misaligned stud with the misalignment at 7°. The Rules allow a maximum of 4° misalignment.

If such misalignment is outside Rule requirements, the link should be removed and replaced.

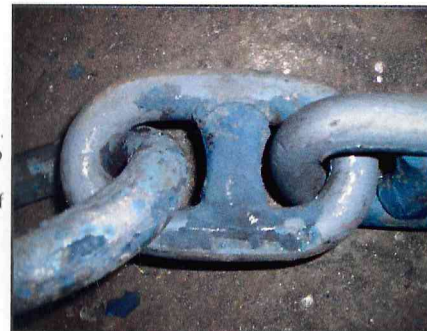
This photograph shows a number of imperfections, including an off-centre stud. The stud is also too large for the diameter of the chain.

If off centre, the link should be removed and replaced.

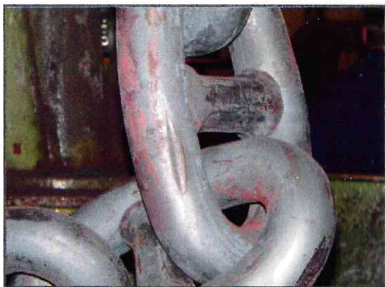
## CD12 Damage From Stud Pressing

This shows marking of the surface from the stud pressing operation. This would act as a significant stress raiser.

If found this should be dressed, if this can be done so that the link remains in dimensional tolerance. Otherwise the link should be replaced.

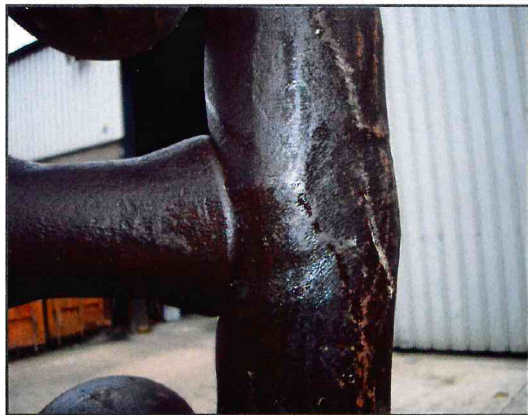
## CD13 Misalignment From Stud Pressing

This shows chain link deformation caused during stud insertion. The force during stud pressing may have been too high or the stud length may be too long. If the deformation is excessive it can cause the dimensions to be under tolerance. It can form a sharp step which acts as a stress raiser leading to early failure.

**Remedial Action:** The manufacturer needs to review the set up and maintenance of their machines. They may need to improve quality control of the stud length e.g. more frequent dimensional checks.

If found this could be dressed if the link remains in dimensional tolerance. Otherwise the link should be replaced.

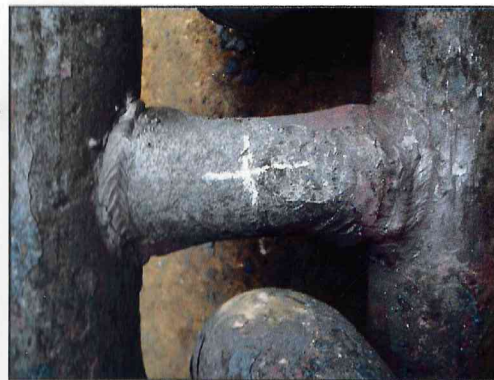
## CD14 Welded Both Ends

LR Rules specify that studs are to be welded at one side only, i.e. opposite the flash butt weld joint.

**Remedial Action:** This link should be rejected and replaced. Other chain from this batch should be examined.

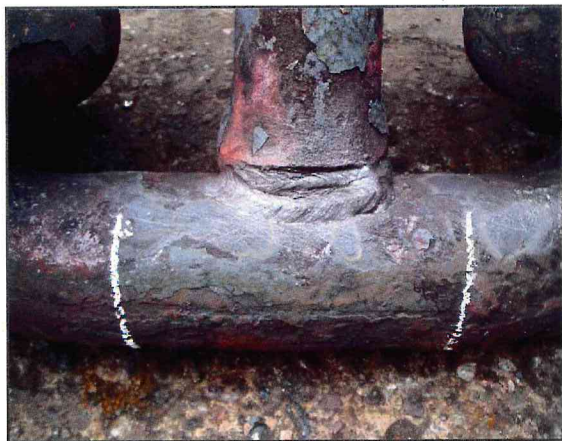
## CD15 Poorly Fitting Stud

This picture shows that a stud has been used which was too small for the size of the link. The gap between the stud and the link has been filled with multiple welding passes.

**Remedial Action:** This link should be rejected and replaced. Other chain from this batch should be examined.

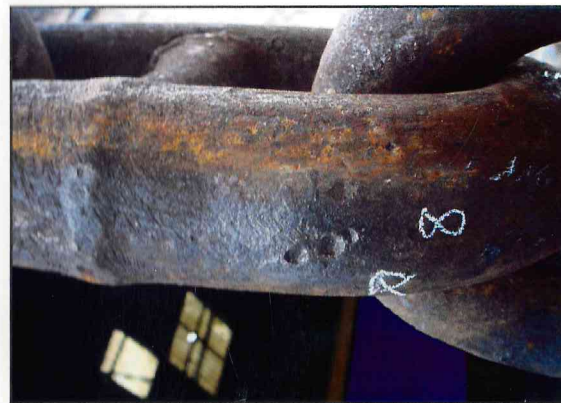
These areas will be subject to rapid heating/cooling cycles and will produce locally hardened structures, with the risk of crack initiation and in-service fracture.

**Remedial Action:** Such imperfections can be removed by grinding, but sufficient material must be removed to ensure that any heat affected steel is removed. MPI should be conducted after grinding to ensure that no cracking remains. After grinding the link must still meet dimensional requirements, otherwise it should be rejected and replaced.

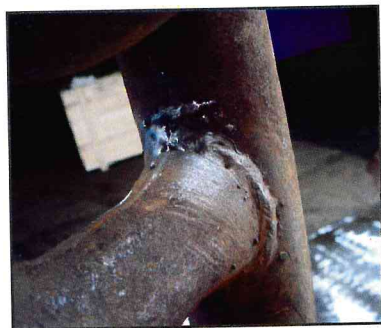
## CD18 Poor Weld Start/Stop

This weld shows a number of different welding imperfections, in particular a poor start/stop. Stud welds are prone to all the types of poor weld profile typical of manual welding.

**Remedial Action:** The weld should be dressed by grinding,

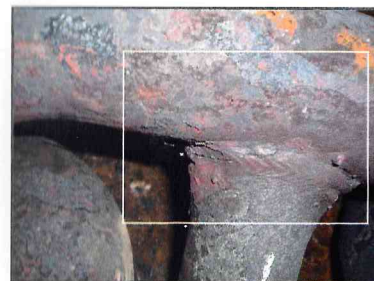
## CD19 Cracking

Welding of incorrectly fitting studs will cause a susceptibility to cracking from contraction stresses. This photograph shows cracking through the weld bead.

**Remedial Action:** The link should be

rejected and replaced and adjacent links checked.

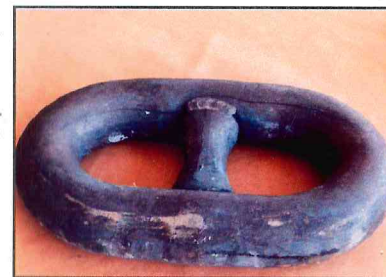
## CD20 Cracking

This U3 link was welded satisfactorily. But at final inspection the crack was found to be present. This crack is likely to have formed due to contraction stresses in the link which 'clinked' (cracked) most probably from charging into a hot furnace.

The crack will have initiated from the stud weld and it has grown to extend all the way around the chain link.

**Remedial Action:** No action, the link should be rejected and replaced.

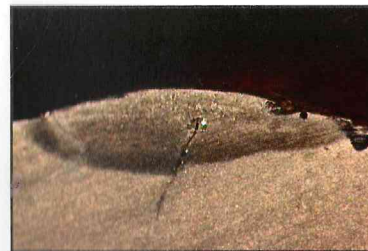
## CD22 Repair Weld

The images shown below demonstrates a poor weld repair on a bar containing a lap or seam of rolling mill origin. Such welding of the link is not allowed in the Rules.

The following macro taken across the section of the weld repair shows the ineffective nature of the repair and the danger from in-service failure.

**Remedial Action:**

This link should be removed and replaced, and other chains from this batch examined thoroughly.

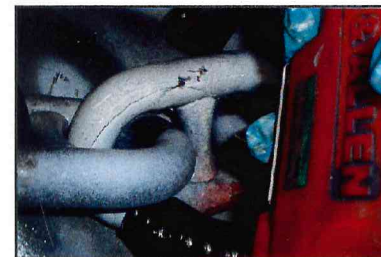
This imperfection is probably a seam, which originated in the bar rolling process, has opened up on proof testing, and has been detected by MPI.

Such imperfections should be picked up by visual inspection or NDE in the rolling mill.

**Remedial Action:**

Such an imperfection may be removed by grinding, followed by MPI to ensure that all of the imperfection is removed. After grinding, link dimensions must still be within Rule dimensional requirements. If repair by grinding is not possible, the link should be rejected and replaced and other chains from this batch examined thoroughly.

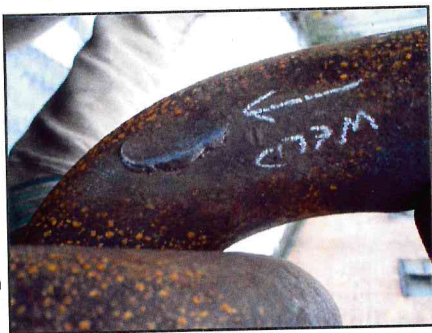
**CD23 Repair Weld**

This shows a weld repair on a link.

**Remedial Action:**

As above this link should be removed and replaced, and other chains from this batch examined for suspect weld repairs.

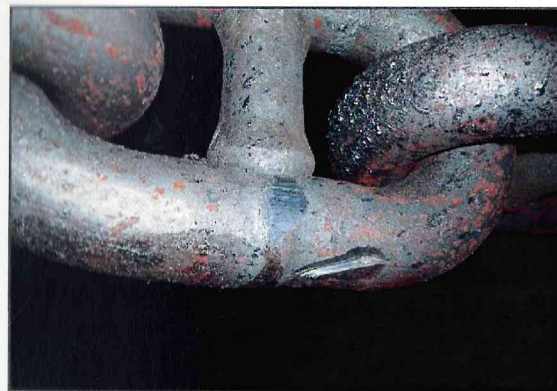
**CD24 Mechanical Damage During Handling**

Mechanical damage can occur on the surface of the link from many different sources in the rolling mill, handling, transport, or during the chain manufacturing operations.

**Remedial Action:** If present such imperfections may be removed by grinding, provided the dimensions remain in Rule tolerances. Otherwise, such bars or any chain manufactured from them should be rejected and replaced.

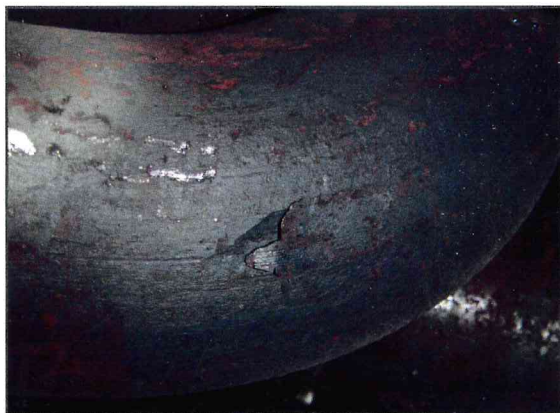
## BD1 Surface Lap (Shell) on Chain Link

Bars must be free from cracks, laps, seams or any other imperfections which would affect the performance of the finished chain.

This surface lap (sometimes called shell) is one example of surface imperfections which are not acceptable. This type of feature originates in the steel casting, and upon rolling produces a lap, where one end is detached from the bar surface.
