# RIZQ Vehicle Inspection

Pre-Purchase Vehicle Inspection Report

JOB 4455

| Make/Model | AUDI Q7 |

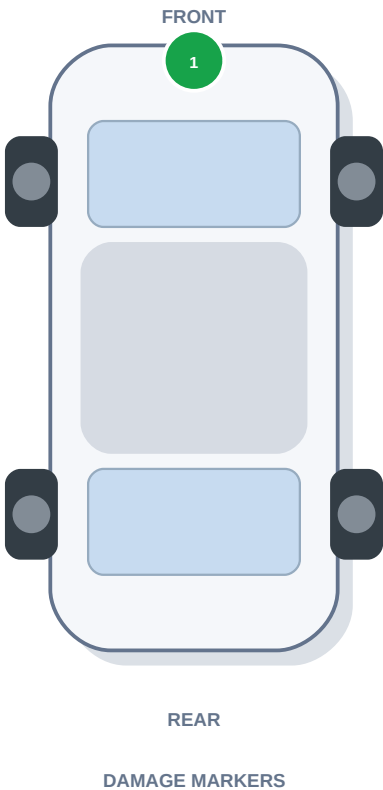
VEHICLE DAMAGE DIAGRAM

Note: Front Bumper Minor Damage Minor damage to the front bumper light scuffing only..

- 1. Front Bumper— Very Good
