# RIZQ Vehicle Inspection

Pre-Purchase Vehicle Inspection Report

69EA3ABA

| Year | 2017 | Make | Ford |

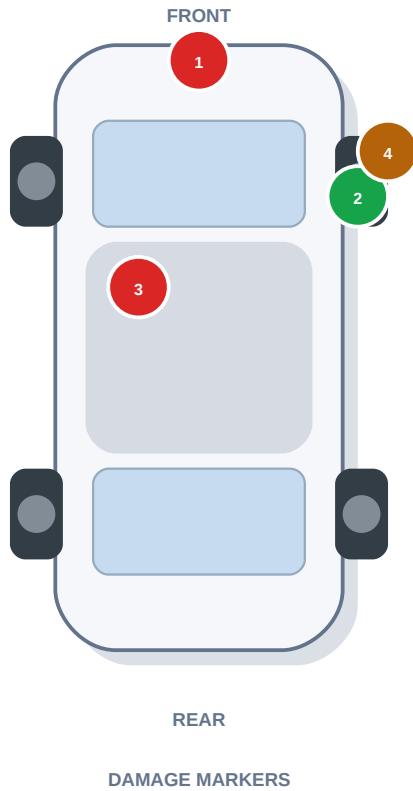
VEHICLE DAMAGE DIAGRAM

Note: Front Bumper Damage Moderate damage to the front bumper scuffs and paint cracking along the leading edge.; Right Front Fender Minor Damage Minor damage to the right front fender.; Driver Seat Tear Tear in the driver seat upholstery.; Front Right Wheel Heavy Scratches Heavy scratches on the right front wheel..

- 1. Front Bumper— Moderate
- 2. Right Front Fender— Very Good
- 3. Driver Seat — Moderate
- 4. Front Right Wheel— Fair

Findings are limited to 4 items, with an estimated repair cost of \$1,000. RIZQ recommends proceeding only if the conditions noted above are addressed.
