## TS01-ODU: Outdoor EEPROM parameter error or Compressor driven chip EEPROM parameter error diagnosis and solution

**Description:** Outdoor PCB main chip does not receive feedback from EEPROM chip or compressor driven chip.

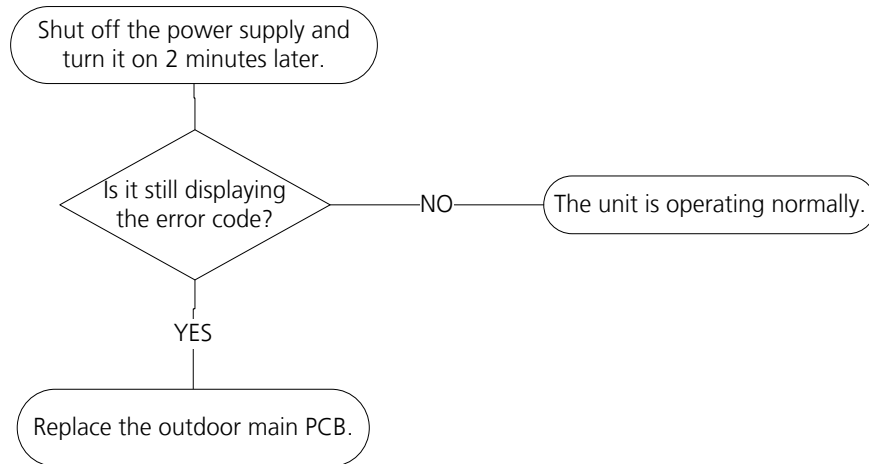
**Troubleshooting and repair:**

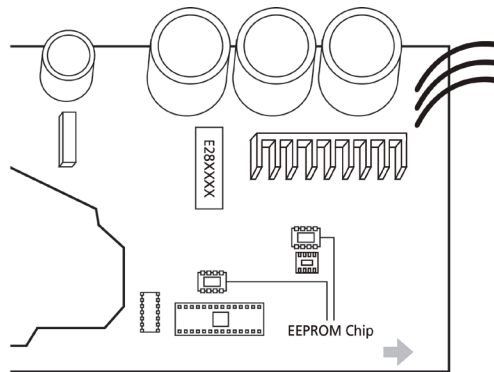
The location of the EEPROM chip on the outdoor PCB is shown in the following image:

**Note:** For certain models, outdoor PCB could not be removed separately. In this case, the outdoor electric control box should be replaced as a whole. This pictures are only for reference, actual appearance may vary.
