## TS01-IDU: Indoor EEPROM parameter error diagnosis and solution

**Description:** Indoor PCB main chip does not receive feedback from EEPROM chip.

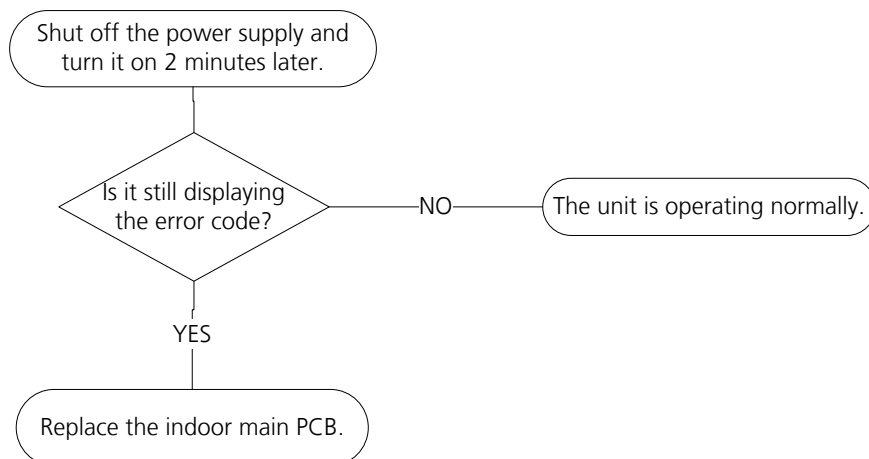
**Troubleshooting and repair:**

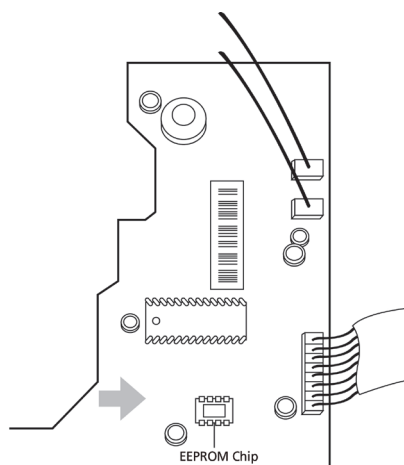
The location of the EEPROM chip on the indoor PCB is shown in the following image:

**Note:** This pictures are only for reference, actual appearance may vary.
