Pre-Purchase Vehicle Inspection Report

2020 Audi Q7 Prestige quattro

Report ID **JOB 4455** · Report Date Sep 27, 2026 · rizqvehicleinspection.com

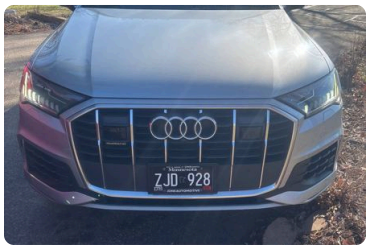
DAMAGE DOCUMENTATION

Front bumper has light scuffing at the lower corner, and the air inlet trim insert at that corner is displaced/broken. All other panels are clean.

1 · Front Bumper — Minor
Light scuffing at the lower corner; air inlet trim insert displaced/broken. Estimate covers R&I bumper cover, replace inlet trim insert and spot refinish.

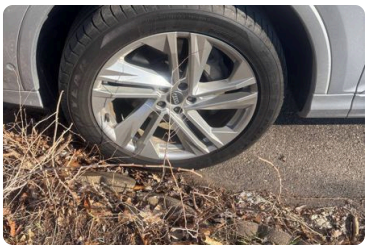
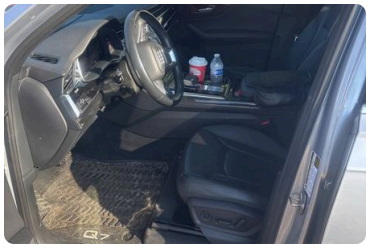
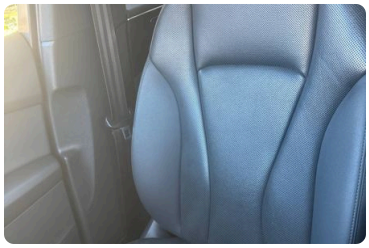
PHOTO DOCUMENTATION — WHEELS & TIRES

Tire Brand	Goodyear
Tire Size	285/45R20
Minimum Recommended Tread	4/32"
Brakes (all four positions)	Normal

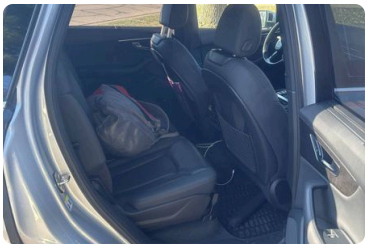
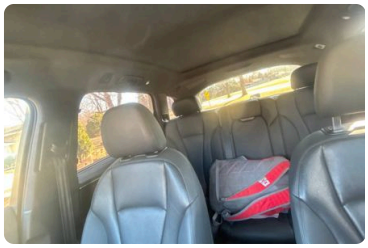
PHOTO DOCUMENTATION — INTERIOR

Area	Condition	Notes
Driver Seat	Normal	
Passenger Seat	Normal	
Rear Seats	Normal	
Dashboard / Virtual Cockpit	Normal	
Center Console & Armrest	Normal	
Headliner / Panoramic Roof	Normal	
Seatbelts	Normal	
Electronics & Controls	Normal	All functional
SRS / Airbag System	Normal	No warning lights
Odor	Normal	Clean

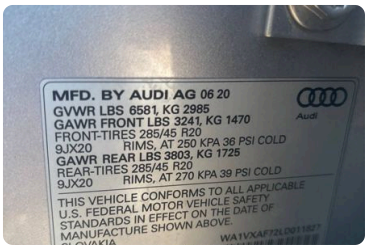
PHOTO DOCUMENTATION — ENGINE, DIAGNOSTICS & LABELS

Engine	Normal — Runs smooth, sounds normal
Transmission	Normal — Engages and shifts properly
quattro AWD	Normal
Leaks	Normal — No leaks observed
Cooling System / Fans	Normal
Exhaust	Normal
Suspension	Normal
Battery — Idle	12.9V Normal
Charging — Running	14.6V Normal
