# Contractor Inspection Report

241 nose dr, Florissant, MO, 63031

# AIRA INSPECTION SUMMARY

AI-Powered Roof Analysis

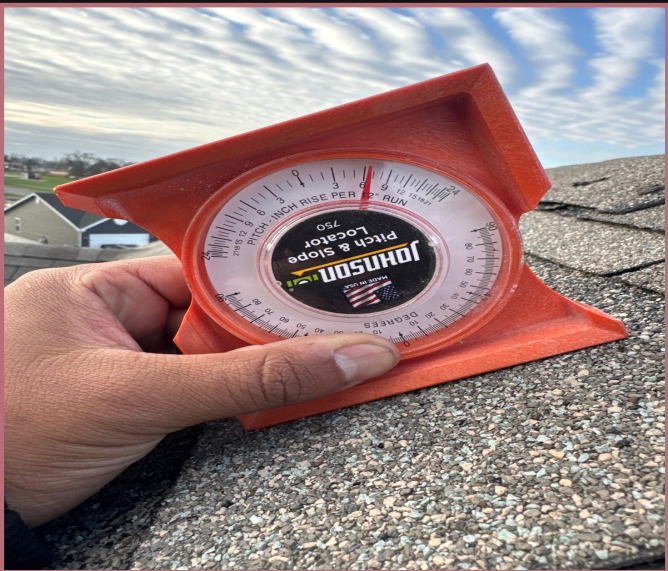
House - Front Slope - Pitch Gauge

The photo depicts a pitch gauge being used to measure the roof slope. The gauge displays an angle, which is a crucial factor in determining drainage efficiency and the suitability of roofing materials. The smooth condition of the roofing surface appears intact.
